# Manhole Inspection Summary

Manhole # S07CC1014MH

Insp Date: **7/6/07 10:48 AM**

**Location** Address: **3801 BELLE AVE**

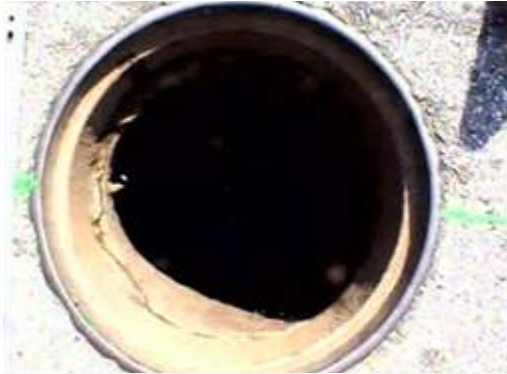
Defect 1

Offset: **2** (in.)

Offset frame

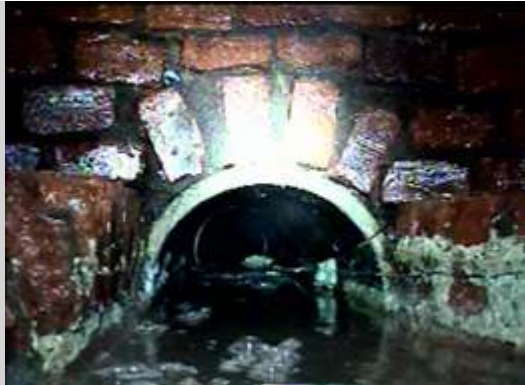
12 O'Clock Outflow

Pipe Height: **13.2** (in.) Rod and Bar (Angled)  
Pipe Material: **Clay** ☐ Pipe Lined  
Invert Depth: **15.40** (ft.) Flow Characteristics: **Slow**  
Deposits: ☒ None ☐ Mud ☐ Sludge ☐ **Debris** ☐ Grease  
Silt Depth: (in.) Deposits Extent:  
Infiltration: **None** Pipe Seal Cond: **Sound**

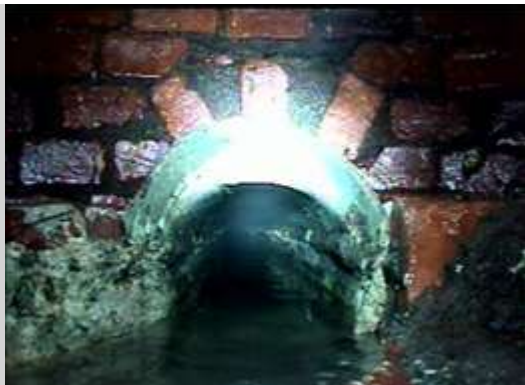
3 O'Clock Inflow

Pipe Height: **15.6** (in.) Rod and Bar (Angled)  
Pipe Material: **PVC** ☐ Pipe Lined  
Invert Depth: **15.26** (ft.) Flow Characteristics: **Slow**  
Deposits: ☒ None ☐ Mud ☐ Sludge ☐ **Debris** ☐ Grease  
Silt Depth: (in.) Deposits Extent:  
Infiltration: **None** Pipe Seal Cond: **Sound**

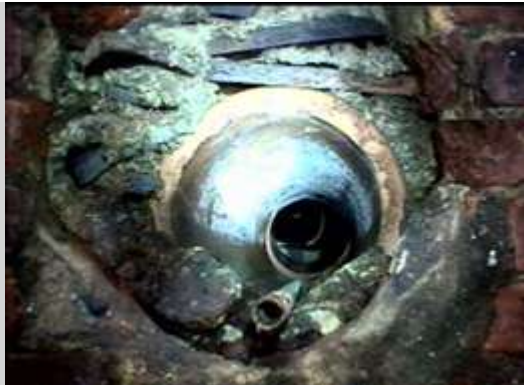
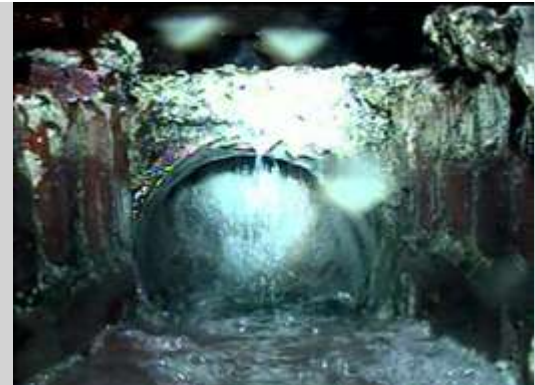
6 O'Clock Inflow

Pipe Height: **12** (in.) Rod and Bar (Angled)  
Pipe Material: **Clay** ☐ Pipe Lined  
Invert Depth: **9.00** (ft.) Flow Characteristics: **Turbulent**  
Deposits: ☐ None ☐ Mud ☐ Sludge ☒ **Debris** ☐ Grease  
Silt Depth: **2** (in.) Deposits Extent: **Medium**  
Infiltration: **None** Pipe Seal Cond: **Cracked**

Drop: **Outside Direct**  
Angled: Reading: (ft.)  
Inv Depth: **14.11** (ft.)  
Drop Condition: **Open**  
Connects To: **Manhole**  
☐ Possible Illicit Connection

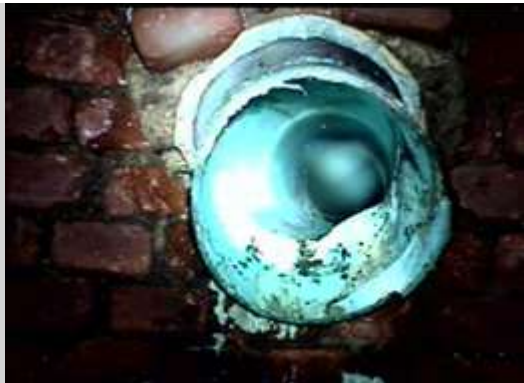
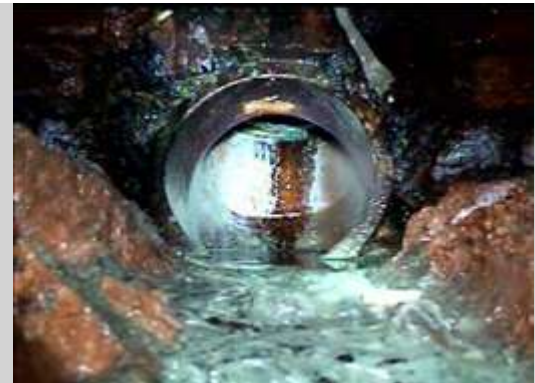
9 O'Clock Inflow

Pipe Height: **14.4** (in.) Rod and Bar (Angled)  
Pipe Material: **Clay** ☐ Pipe Lined  
Invert Depth: **10.05** (ft.) Flow Characteristics: **Fast**  
Deposits: ☒ **None** ☐ Mud ☐ Sludge ☐ Debris ☐ Grease  
Silt Depth: (in.) Deposits Extent:  
Infiltration: **None** Pipe Seal Cond: **Sound**

Drop: **Outside Direct**  
Angled: Reading: (ft.)  
Inv Depth: **13.91** (ft.)  
Drop Condition: **Open**  
Connects To: **Manhole**  
☐ Possible Illicit Connection
